FO-404 - Coyote Tibiae and Fibulae Comparative Pathology Set Order code: 4007.F0404

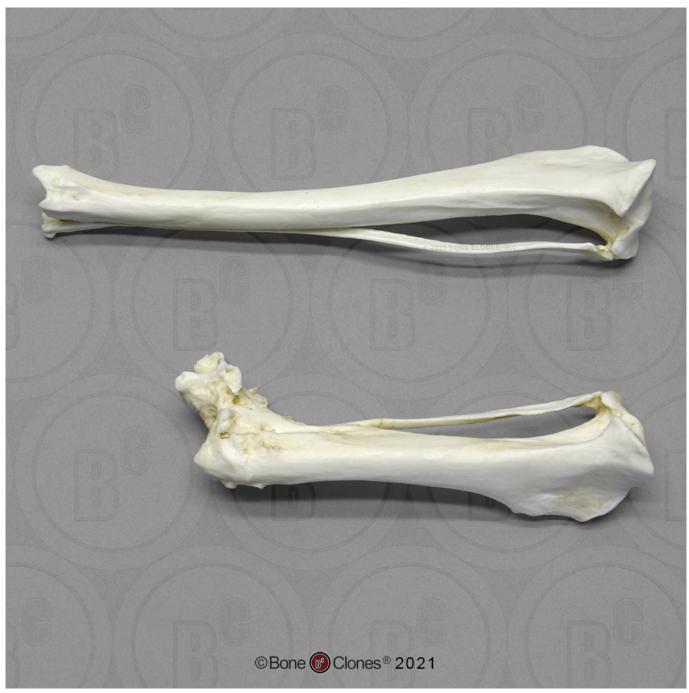
Quantitative unit ks The wound to this canid tibia and fibula was the result of trauma sustained by impact with a vehicle. Constriction of the surrounding muscles during the healing process caused a severe deformation of the bones, including shortening of their total length by 1.5" (3.8 cm). This animal no longer had the use of this leg but was obviously able to survive for an extended length of time. Ironically, this specimen was collected along a roadway and, presumably, met his fate during a second vehicle collision.
